DATE: November 15th, 2023
TO: Members of the Board of Directors
FROM: John Gibson, Chief Plant Operator
SUBJECT: OPERATION REPORT: October, 2023

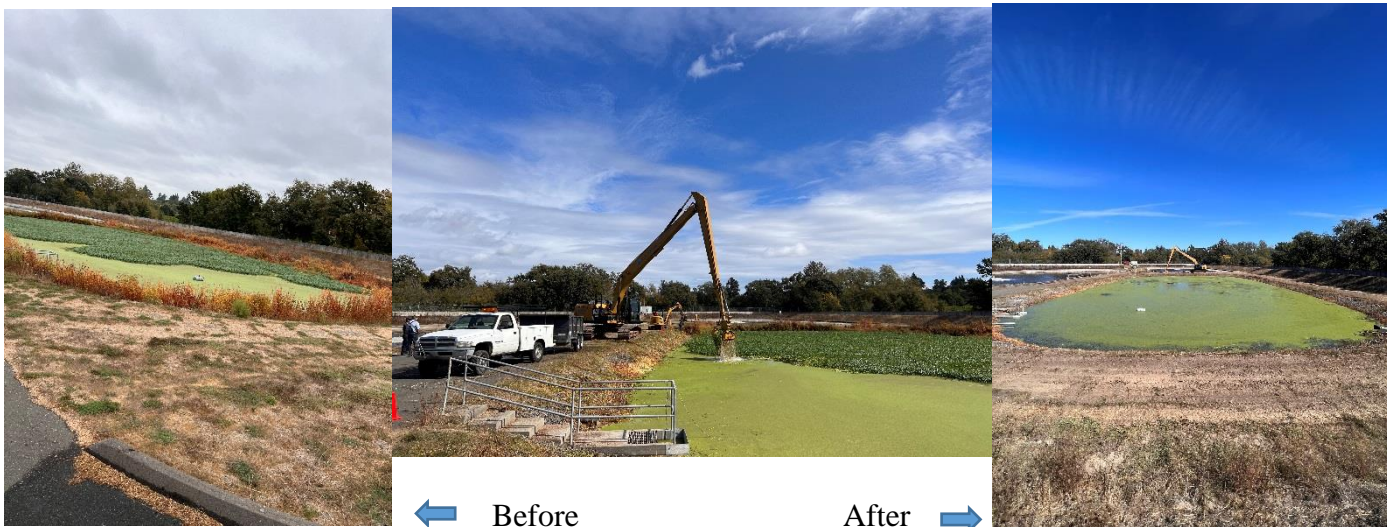
Settling Pond Floating Weed Removal

Water Works utilized a 60-foot-long reach excavator with a 4-foot perforated clam shell attachment to remove large floating weed mats from the settling pond. These mats were then dewatered in the dump trailer and processed in the compost facility. Additionally, vegetation growth around the pond perimeter was removed and composted.
