May 12th – June 6th 2022 Operations Report

GRATON COMMUNITY SERVICES DISTRICT

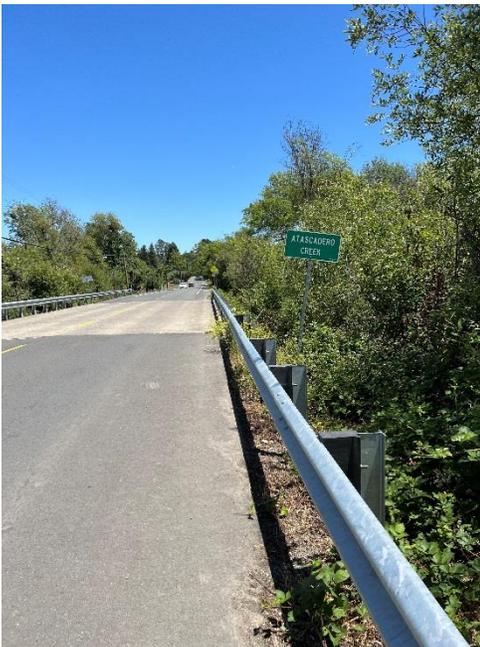
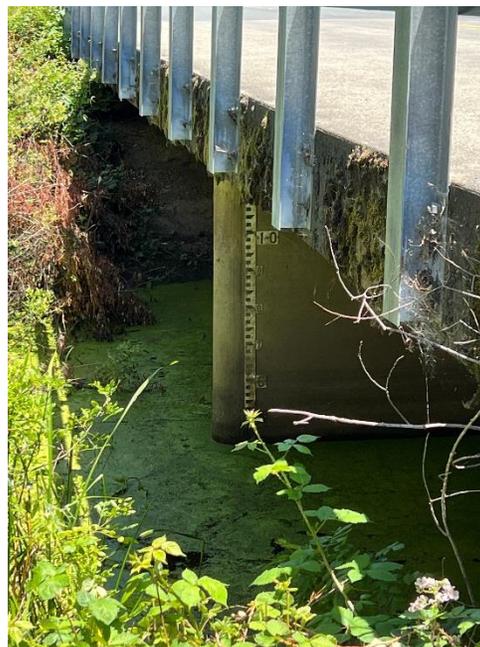
During the discharge season from October 1st to May 14th the District is allowed to send tertiary treated water to Atascadero creek at a rate of 1% of the creek flow. The flow is calculated using a staff gauge located upstream of the plant under the Green Valley Rd. bridge. The depth of the creek is entered into a formula to find the flow of the creek in million gallons per day (MGD). Operators set the rate of discharge to 1% of the creek at CVS#2 by opening or closing the discharge valve until the effluent flow meter is reads 1% of the creek flow in gpm. Discharge to Atascadero Creek was shut down on May 12th.

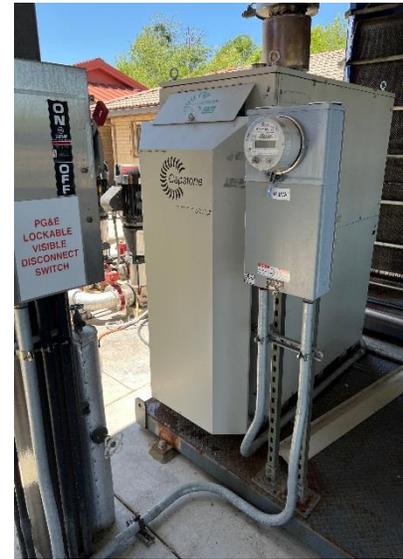
Most of the 40,000-hour maintenance has been completed on the turbine. There are a few parts however that have been on order and should be received by Cal Microturbine in about a week or two. The remaining parts to be replaced are: 1) fuel metering valve 2) EMI filter 3) igniter 4) engine air filter 5) inline fuel filter. Once these parts are received Cal Microturbine will schedule a site visit to complete the 40k hour maintenance.

Photo of the Capstone Microturbine

After further investigation and follow up from Capstone, I discovered that the major parts associated with the overhaul were replaced less than 20,000 operating hours ago as part of unscheduled incidents.

Date	Hours	Primary work
7/30/2018	20,486	Diagnosed failed RFC
8/31/2018	20,486	Replaced RFC
4/22/2019	23,644	Installed new DPC with 3 new IGBT's. Found signs of failed Powerhead
5/15/2019	23,644	Replaced Powerhead and Recuperator

Maintenance Interval	Component	Maintenance Action	Comments
Every 40,000 hours	EMI Filter	Replace	Order acknowledged but still not received. Awaiting lead time update from Capstone.
	Frame PM	Replace	Order acknowledged but still not received. Awaiting lead time update from Capstone.
	TET Thermocouple	Replace	Supplied with replacement Recuperator on 5/15/2019. Not due for scheduled maintenance replacement until 63,644 system hours
	Powerhead	Replace ⁴	Replaced on 5/15/2019. Not due for scheduled maintenance replacement until 63,644 System hours
	FB RFC Pump	Replace	Replaced on 8/31/2018 at 20,486 hours. Not due for scheduled maintenance until 60,486 hours
	SPV	Replace	This unit doesn't have an SPV so upgrade is Not Applicable

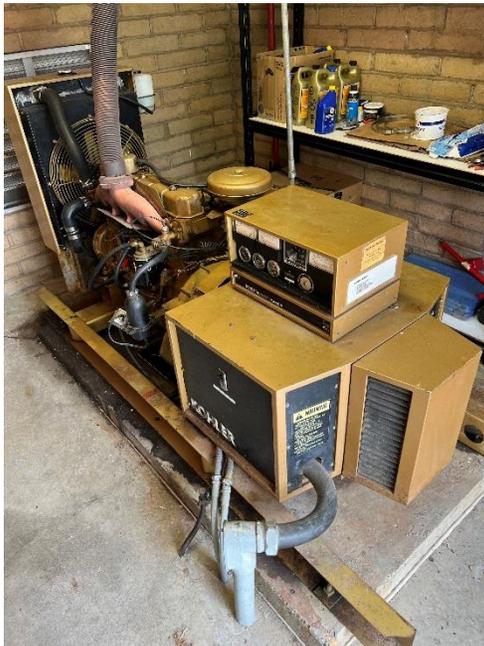
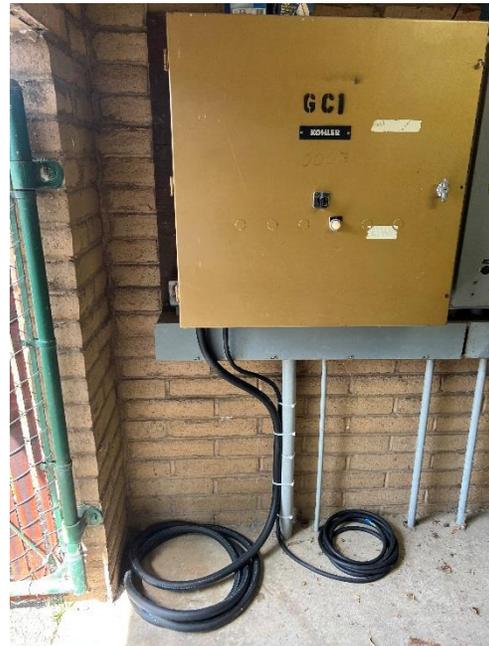
The Lift Station #1 natural gas generator has been wired back into service and the diesel backup generator disconnected and returned to Cal West rental agency. An extra set of cables were installed in case of an event that a rental generator was needed in the future. A two-day run test performed on the generator and showed that the generator leaks and burns oil at a rate of about 2.5 quarts in 35hrs. Operators will monitor and check the fluid levels daily when on duty.

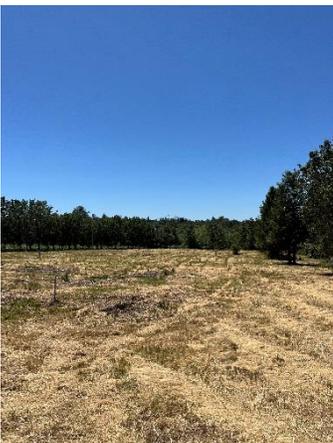
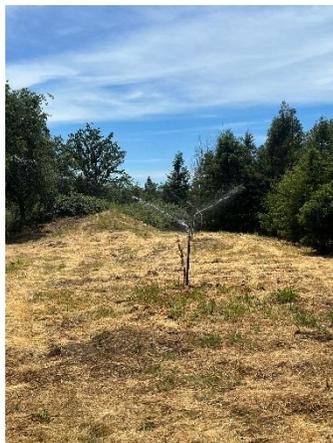
Firescape Mulching and Mowing completed mowing of the 20 acers of irrigation fields and plant grounds and roadways. Operators began inspecting and testing each section of the irrigation system and making repairs to any damaged irrigation pipes or sprinklers.
